Lead Based Paint Survey Report

**5 Library Lane
Woodstock, NY 12498**

**Flatley Read, Inc.
P.O. Box 104
Schuylerville, NY 12871
(518) 577-5681
EPA License Number: LBP-F-157741-1**

Date of Site Visit: 2/9/21

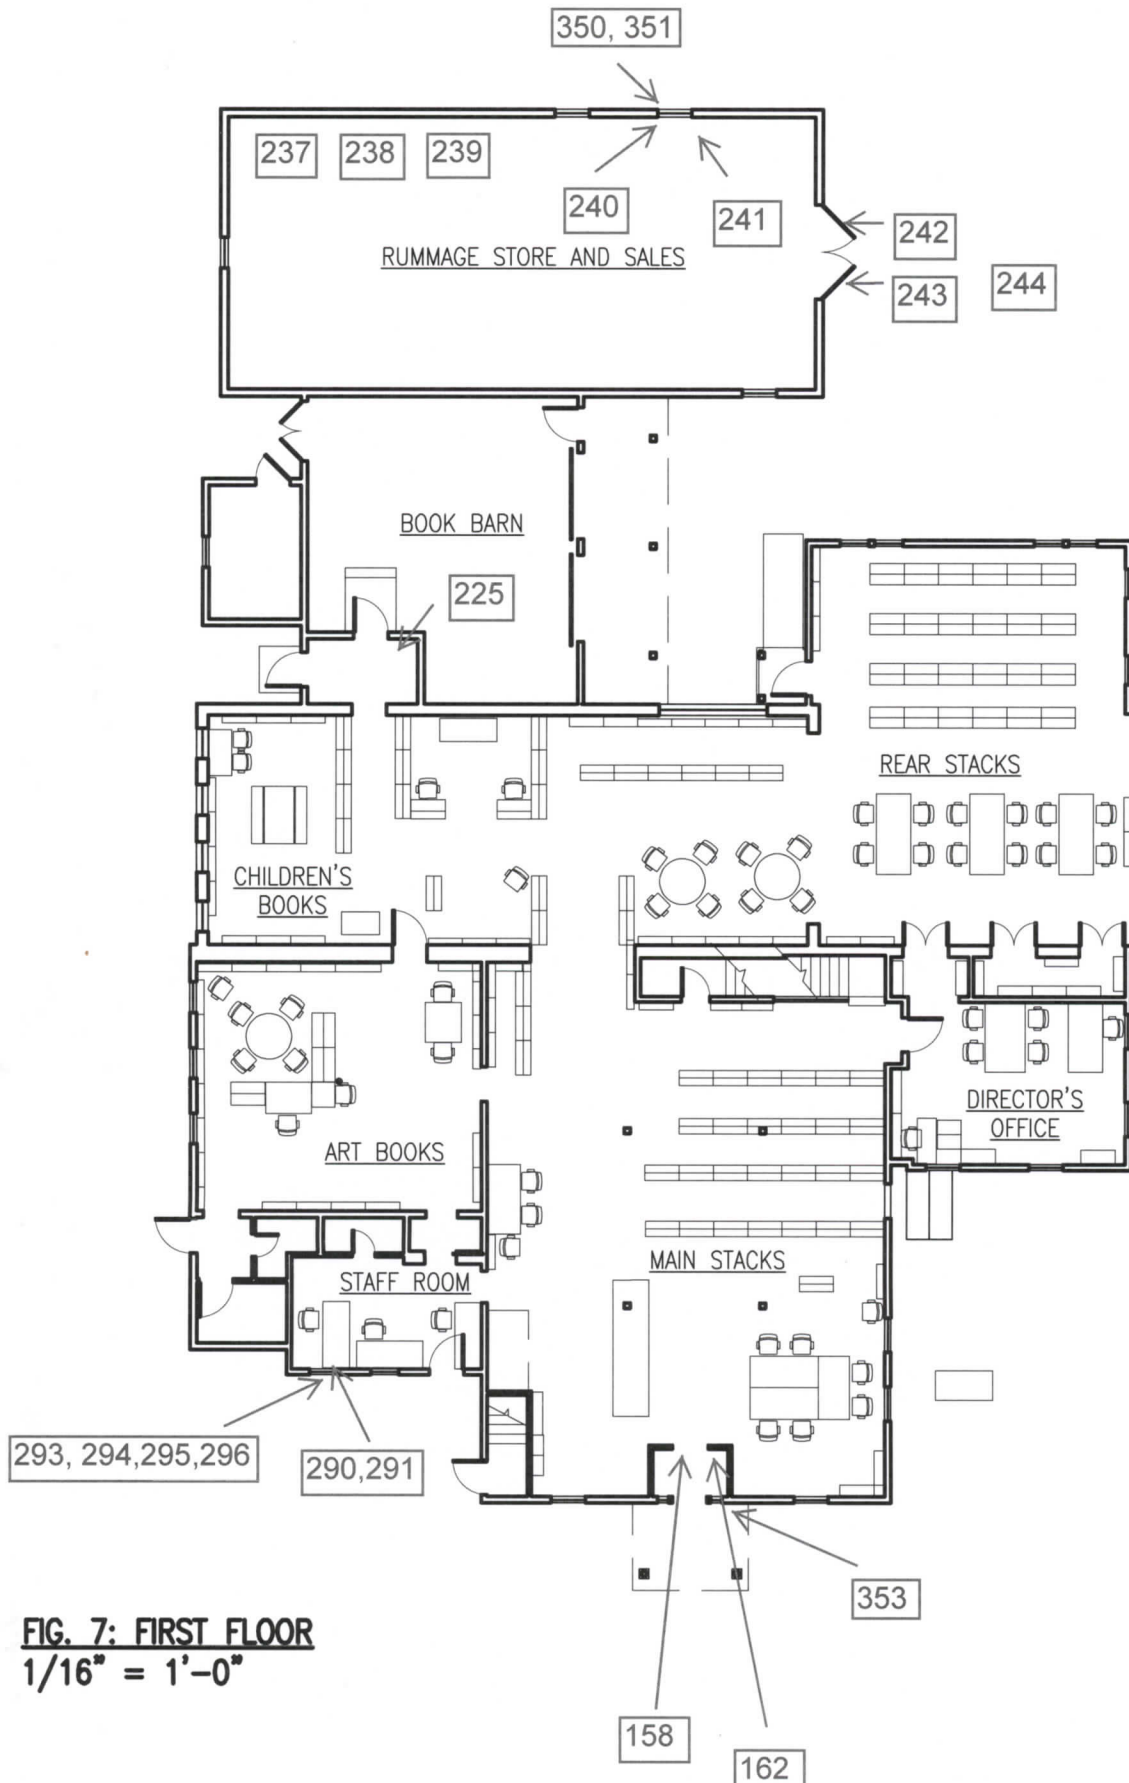
FIG. 7: FIRST FLOOR
1/16" = 1'-0"

Spectrum Project #21-131
First Floor XRF Positive Readings
Sample Date: February 9, 2021
